July 30, 2008

Confidential Inspection Report

INSPECTION CONDITIONS

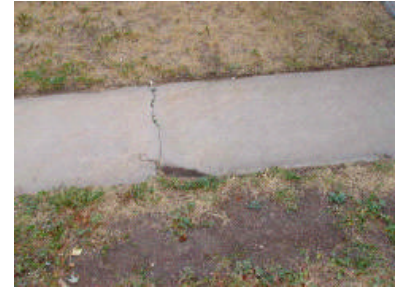
Cracks noted are major, Surface raised/settled.

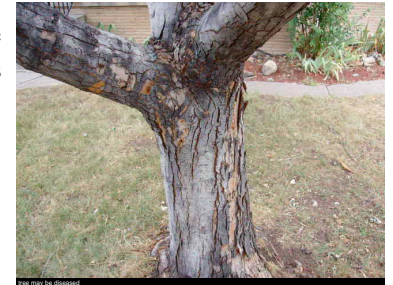
Have Maple tree in front yard checked for disease. Tree is touching and overhanging the roof of garage. It is also in the power lines. Damage is possible.

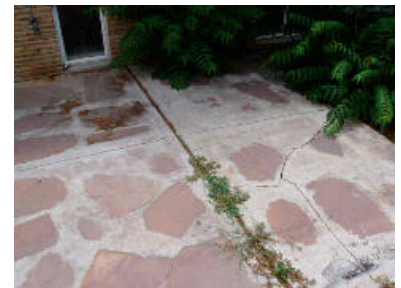
Cracks noted - typical.

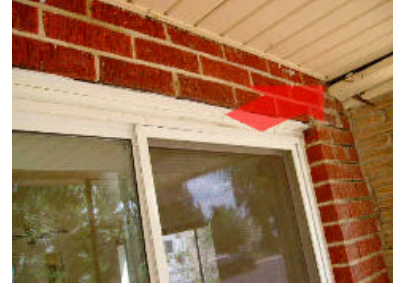
Metal, Damage to soffit. Typical cracking.

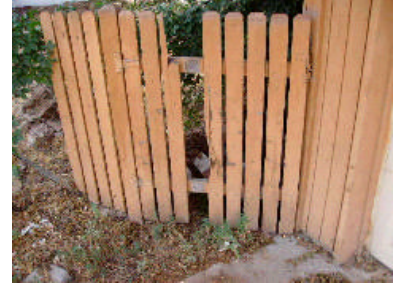
Repairs needed at gate.

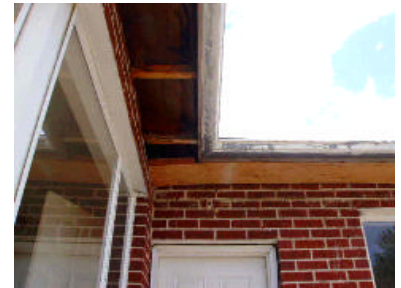
MATERIAL: Wood,
CONDITION: Damaged and missing soffit - rear.

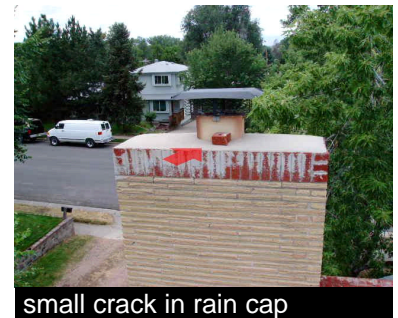
MATERIAL: Brick. photo = small crack in rain cap.

small crack in rain cap

CONDITION: Patch cracks in chimney cap, Small amount of tuck pointing needed.

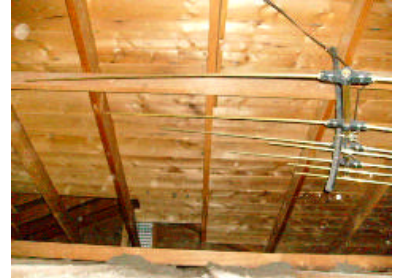
Attic is full size, Conventional framing, Viewing was limited, to observing from hatch areas only. Access is restricted.

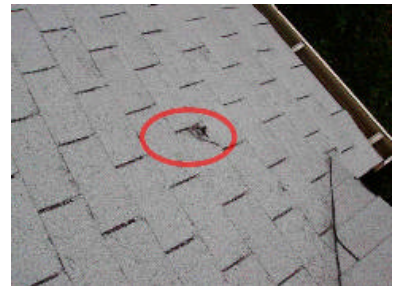
Damage noted - hole through shingles over back porch.

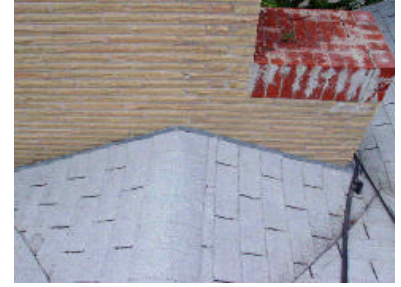
Metal, No counter flashing at chimney.

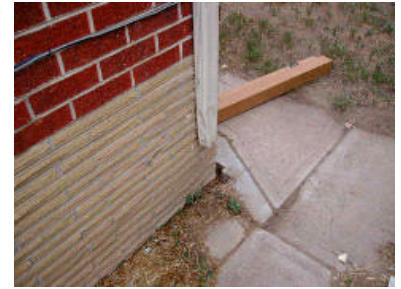
Full, Debris in gutter, Missing downspouts, Overflow at front - rt of porch.

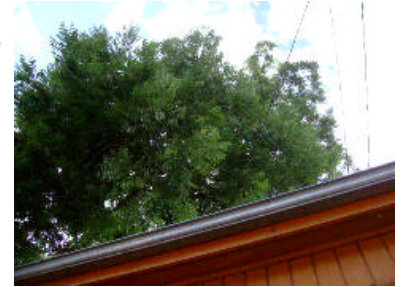
CONDITION: Appears serviceable, Debris in gutters. Neighbors electrical service is too close to roof and tree overhang the roof. Power company should take care of both.

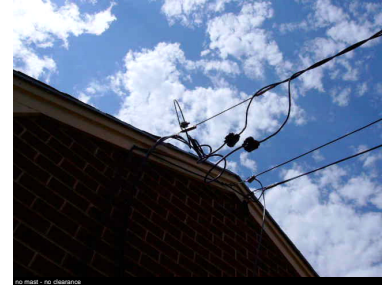
Overhead, 110/220 Volt, Circuit breakers, Damage/Defects noted: Overhead conductors need repair by the power company. No mast. Neighbors service too close to garage roof.

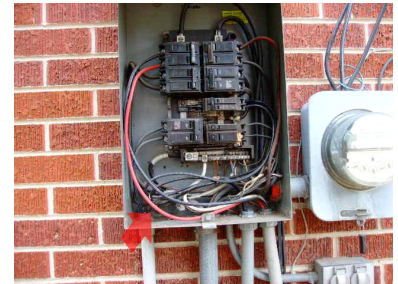
wasp nest

Unused openings in the panel are missing covers, Improper moisture seal at top of box. Wasp nest in box.

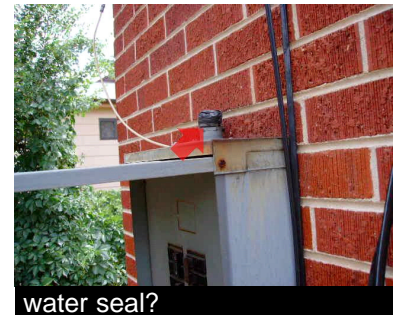
water seal?

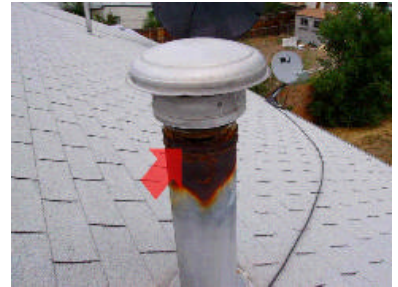
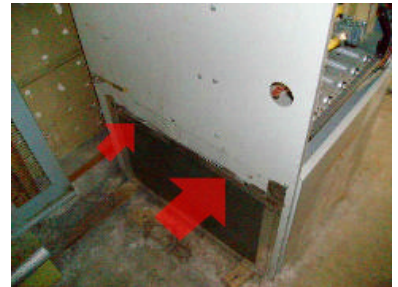
- PRIMARY UNIT: Noisy vent fan. Wire spliced outside junction box.
- PUMP/BLOWER FAN: Appears Serviceable.
- COMBUSTION AIR: Appears serviceable.
- VENTING: Noisy fan. Vent stack rusted through. Can cause CO to back up into living areas.

- AIR PLENUM: Air leaks noted- Sealing is recommended, poor patch on side of air handler.

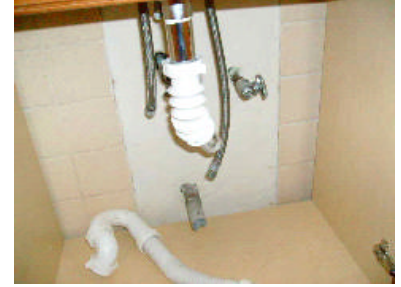
BATH LOCATION: Downstairs.
CONDITION OF SINK: Disconnected.

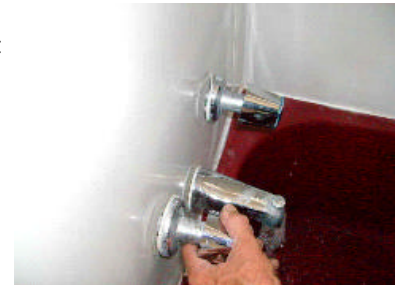
BATH LOCATION: Upstairs.
CONDITION OF SINK: Appears serviceable.
CONDITION OF TOILET: Appears serviceable.
TUB/SHOWER PLUMBING FIXTURES: The following problems were noted at the tub/shower drain: Mechanical drain stopper is not operational at tub. Shower head appears serviceable, Fixtures loose,

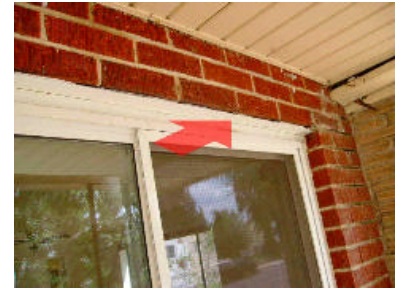
TYPE & CONDITION: Steel, Broken windows X 5 basement.
 Caulk picture window.
 Inoperable - basement livingroom - all.
 Missing screens X 7 - basement.
 Bathroom upstairs - broken windows x 2.

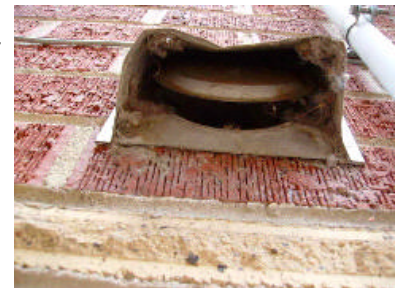
CONDITION: Plumbing appears serviceable, Dryer venting is provided. Clean back vent to close flap - entry for insects, rodents and birds.
