Confidential Inspection Report

August 2, 2008

Executive Summary: This report reflects a visual inspection of a restaurant in half of a masonry construction building constructed in 1959. The building shows a fair level of maintenance except in HVAC systems which are outdated and in poor condition. Workmanship appears to be professional with the exception of the electrical system which show several dangerous alterations reflecting handyman quality work.

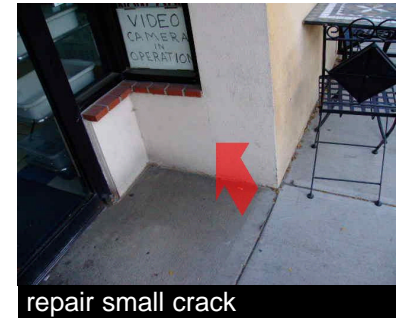
Masonry, Stucco. photo = small crack in stucco at from door.

repair small crack

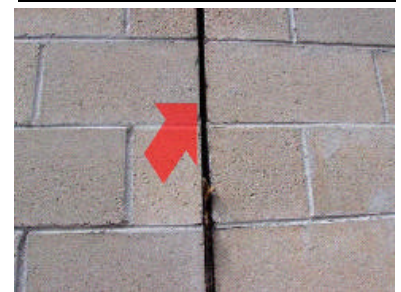
Good, Piece of expansion joint missing X 3. Replace to prevent damage from freezing water.

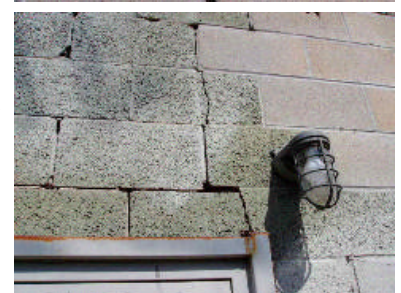
Differential movement at back door - repair needed. This most likely cause of this movement is the missing downspout on the SW corner. Soil has moderate clay content. Expansive soils can swell to 15 time dry volume when water is added.

Differential movement at back door - repair needed. This most likely cause of this movement is the missing downspout on the SW corner. Soil has moderate clay content. Expansive soils can swell to 15 time dry volume when water is added. Small crack at top of S wall center. Small crack at front door.

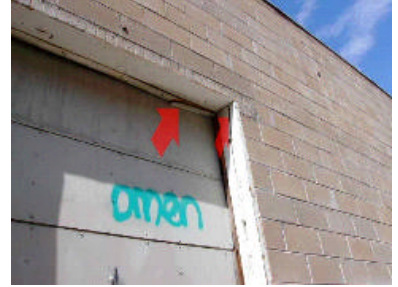
Front Entry Doors: Good condition.
Rear Entry Doors: Good condition.
Overhead/Sliding Doors: Damaged frame Fair condition. Door is difficult to latch.

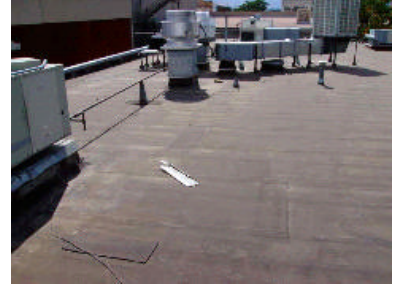
Roof cover appears to be in good condition.

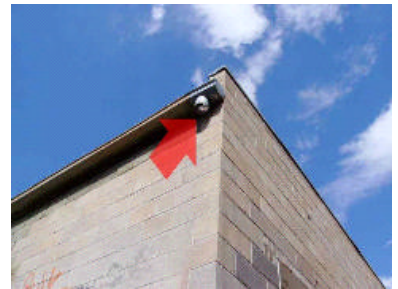
Steel. Fair overall condition. Missing downspout is noted SW.

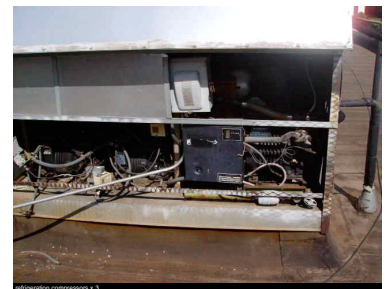
unit 1 = 3 refrigeration compressors - ancient, noisy, in poor condition - 2 operational.

Unit 2 - combo - over 20 years old - operational - clean and service.

Unit 3 - evaporative cooler - not operational.

Unit 4 Same as 2 - not operational at time of inspection. HVAC service man says overheated - needs cleaning.

Unit 5 - freezer compressor - operational, ancient. All equipment is old and should be certified.

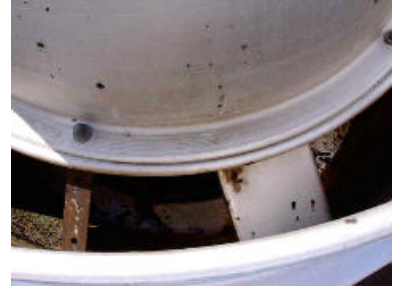
grease traps x 2 operational at time of inspection.
Clean East unit.

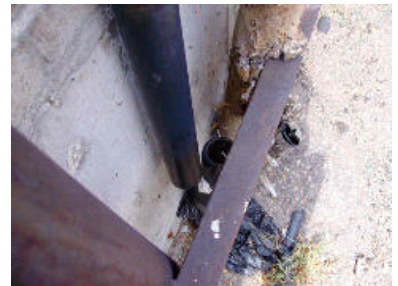
Sewer.
Interior Waste Lines: Predominant Type: PVC.
Drainage: Good.
Evidence of past or present leaks? None.
Venting: Broken vent on side of building of unknown use. Owner thinks it may be part of grease trap system. No access to crawlspace.

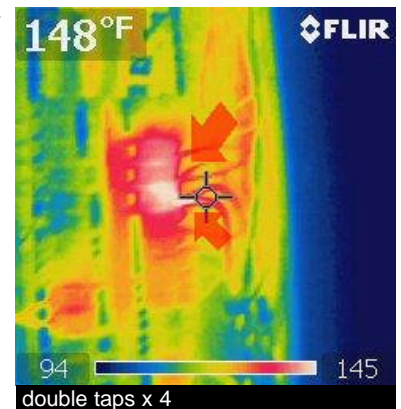
No defects observed except in breaker box. Overheated and overloaded breakers are over heated to as much as 150F - fire hazard. Have electrical system certified by licensed electrician.

Workmanship and Layout: Double wiring taps noted. Fire hazard - extremely overheated breakers.

Circuit Breakers: Size vs Indicated Use: Oversized circuit breakers are noted - have certified by licensed electrician.

Areas of Concern: Handyman wiring is noted in the following locations: breaker box.

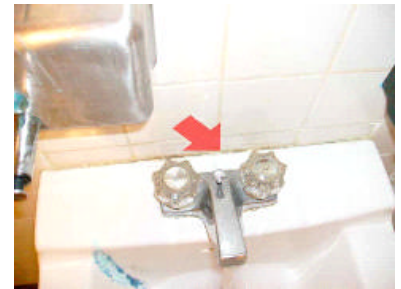
Employee bath okay
Caulk sink - ladies and men's room.

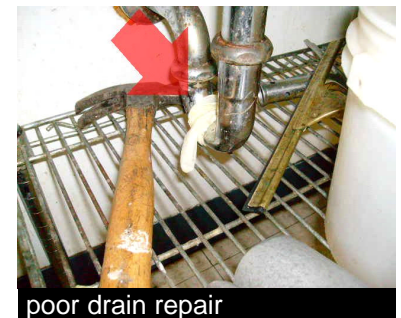
Front sink - garbage disposal not working.
Glove used to repair hand wash sink.
Display cooler - clean compressor.
Display freezer - clean compressor.

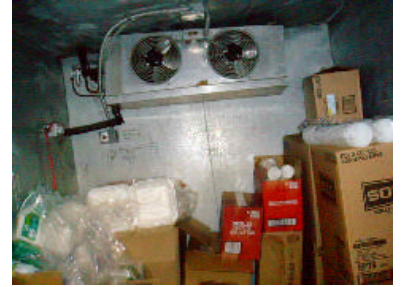
Refrigerator - 40 F. Clean cooling coils.
Freezer 16 F.
Cooler not operational. Door missing, compressor
not working, heat exchange unit mount broken.
Front cooler - 42F. - clean cooling compressor.
