Confidential Inspection Report El Rancho

Prepared for: El Rancho Enterprises LLC

April 6, 2011

RE: El Rancho

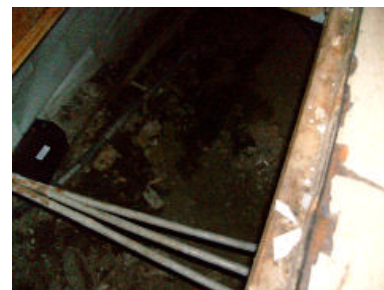
Moist - no moisture barrier, fallen insulation, mummified rat in rat trap.

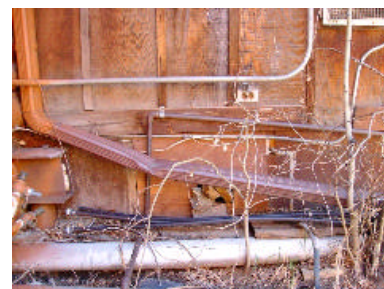
Earth/wood contact - rear.

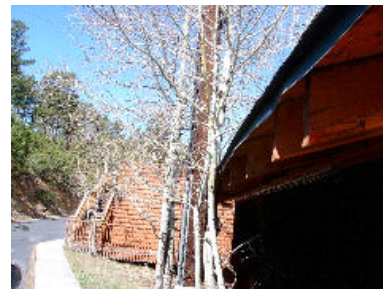
Trees are contacting the building - Remove on all sides

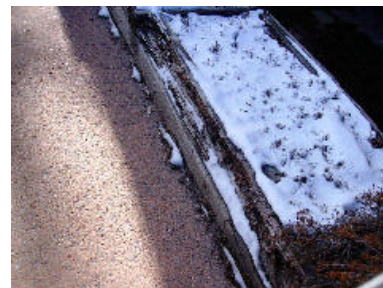
Rotted planter box - patio.

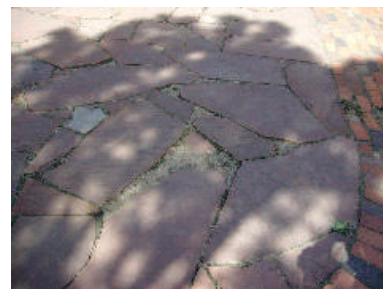
Repair joints - flag stone - E patio.

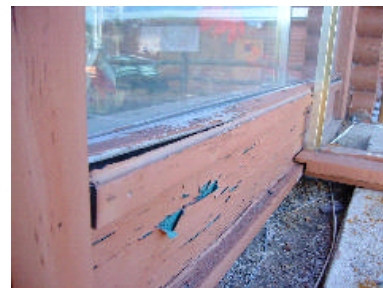
Poor, refinish.

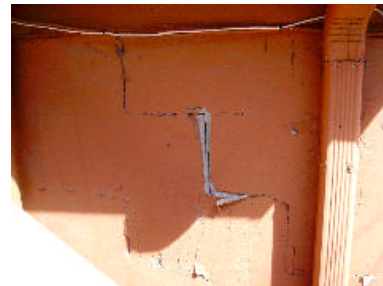
Structural cracking is found - rear.

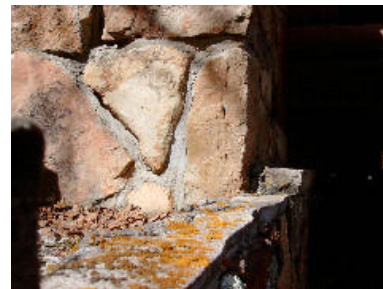
Repair masonry at front of building and right of front entry

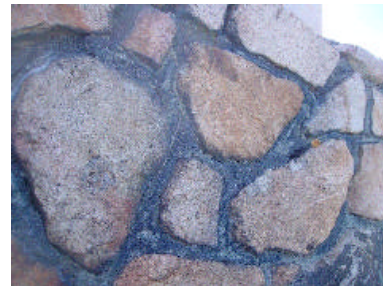
Repair masonry at chimney.

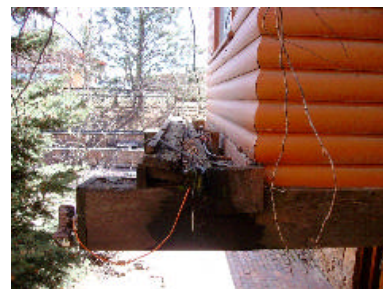
Rotted lumber on cantilever - E patio.

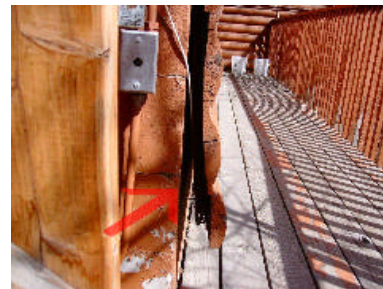
Siding separated from building - rear.

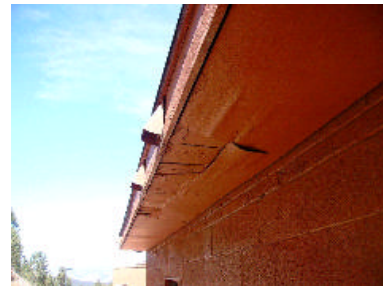
Water damage -soffit - rear - west

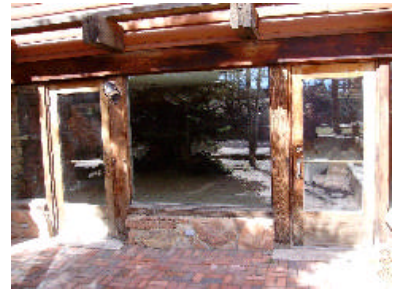
Front Entry Doors: Good condition.
Rear Entry Doors: Refinish doors and trim - E patio.

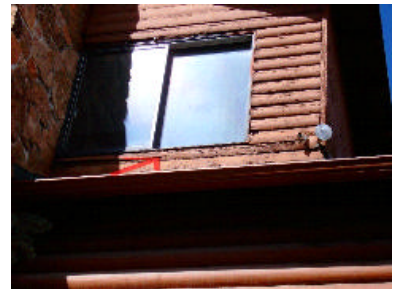
Wood trim boards are rotted in some areas.

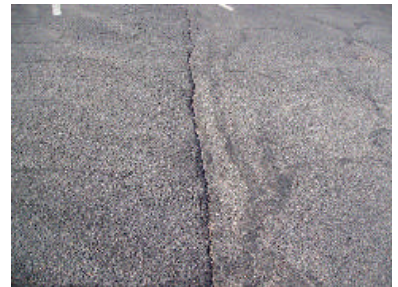
Surfacing Material: Asphalt.
Condition: Some expansion cracking is present. Normal for aged materials. Cracks have been sealed and maintained. Slight maintenance now due.

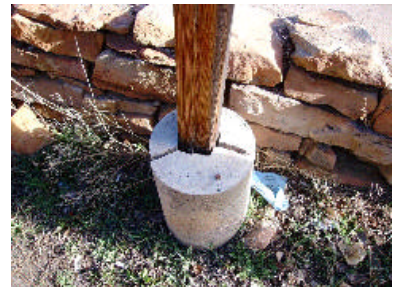
Fencing: Wood fencing. Broken concrete post support

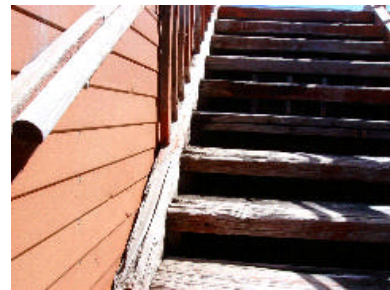
Stairs to roof rotted, handrail weak - replace.

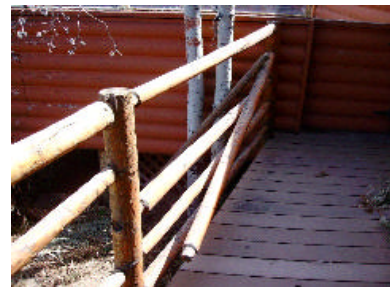
Stairs to ramp to deck - replace handrail.

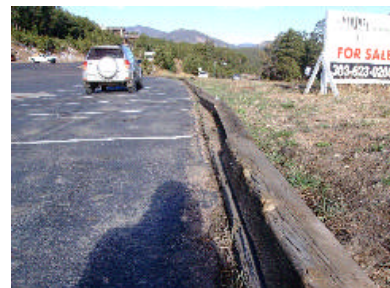
Retaining walls - timber wall at front of parking lot - repair needed.

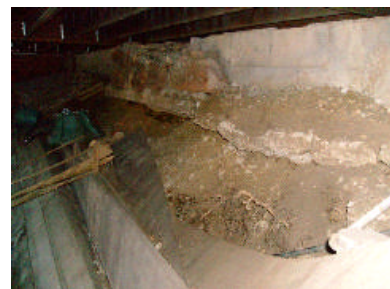
Under patio - retaining wall has failed, soil eroded from under foundation.

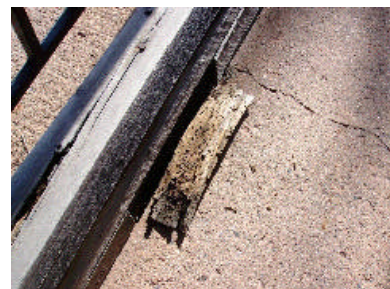
Ramp to patio - rotted timbers x 4.

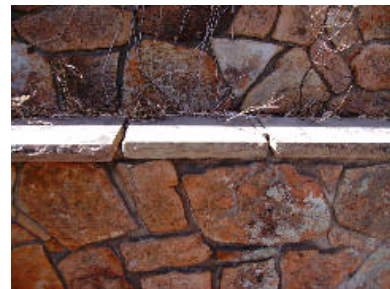
Repair masonry - rock walls E patio.

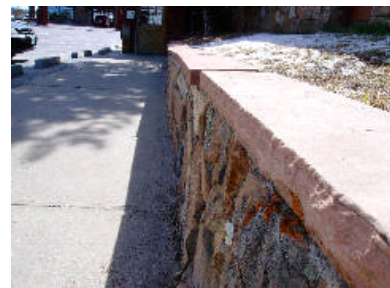
Rock wall at front walk - failed - repair.

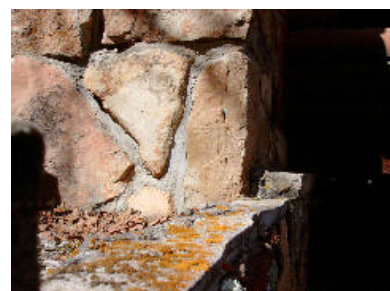
Masonry needs repair at E patio walls.

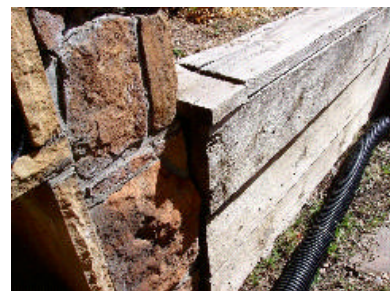
E patio timber wall failed.

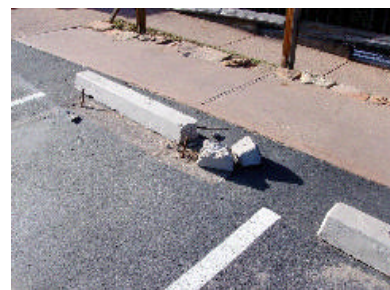
Replace wooden steps to E patio.

Loose trex boards on deck.

Parking stop broken.

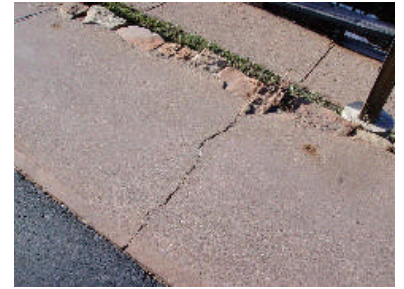
Sidewalks - typical cracking - repair due.

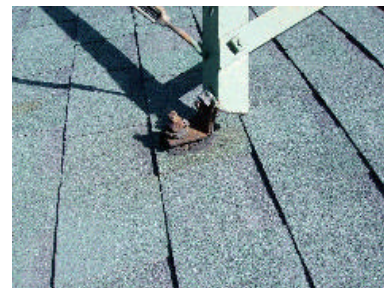
Tenants report active leakage. Roof has been replaced - still leaks.

Gable roof okay. Flat roof - installed with no flashing over deck. Many places of ponding. Leakage at sign mounts - gable, Missing shingle - under sign. Sign mounts leaking.

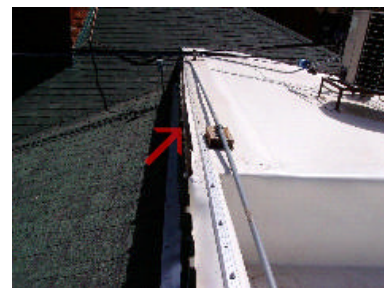
Some flashing not installed on flat roof at intersection with gable roof. Open route for water penetration.

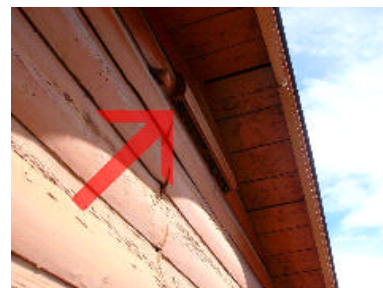
Vent plugged - East. Roof vent(s)

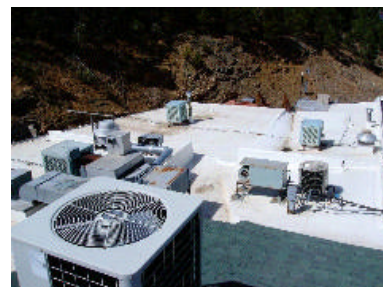
Improper mount swamp cooler - not connected, may be leaking. Swamp coolers x 5 - nonworking.

Vent x 1 - nonworking.

Compressors x 5 AC and cooler/freezer - all except 2 are recently installed.

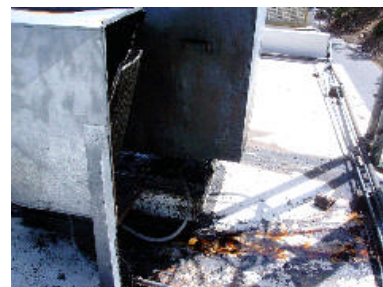
Stove hood vent - clean.

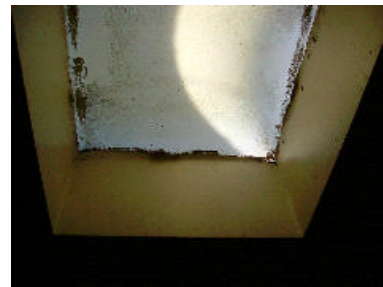
Skylights - leakage -kitchen x 2.

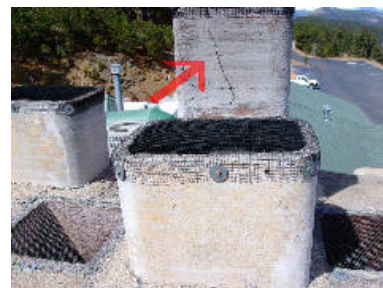
Center chimney - No rain cap, concrete cap needs repaired, soot on masonry joints indicate cracked liner. Do not use until proper vent from gas insert is installed. East chimney - repair masonry and concrete cap.

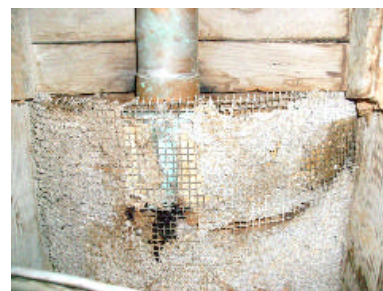
Asbestos pipe protection - crawlspace downstairs from kitchen

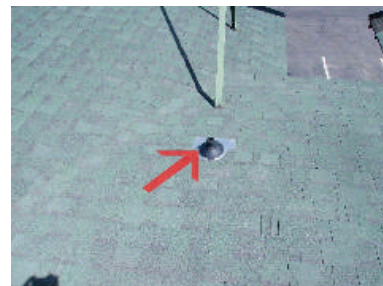
- Sewer.
- Interior Waste Lines: Predominant Type:* PVC, Cast Iron and Copper.
- Drainage:* Good.
- Evidence of past or present leaks?* Leakage under kitchen and around toilets.
- Venting:* Vent pipe too short x 4. Can be blocked with snow.

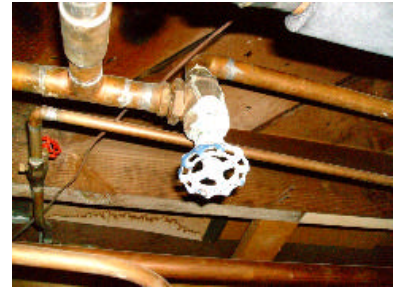
Booster heater - kitchen crawlspace - new possible asbestos insulation.
 Gas water heaters x 3. Man 2005, properly installed 2- 80 gal, 1-119 gal.
 Main shutoff for water heaters corroded.
 Top floor x gas heaters x 2. 67.9 gal. - noisy from sediment.

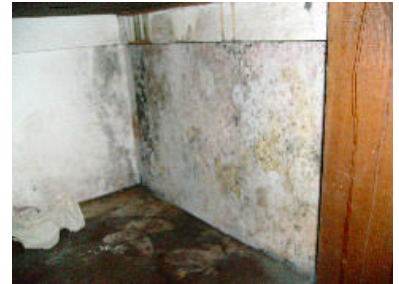
Men's room basement - leaking drain.
 Bucket sink - ladies room basement - leaking faucet - mold growth in closet.
 Bar sink - missing shutoff handles.
 Room 1 - stopper not working.
 Room 6 broken sink.
 Room 2 - stopper not working, caulk tub at floor.
 Room 4, 5, 6, 8- grout and caulk tub.

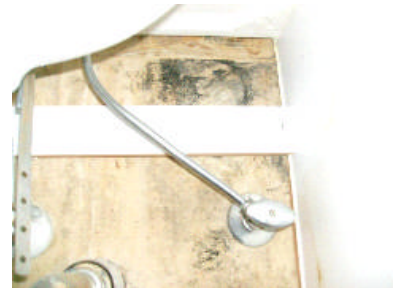
Women's - mold growth in vanity.

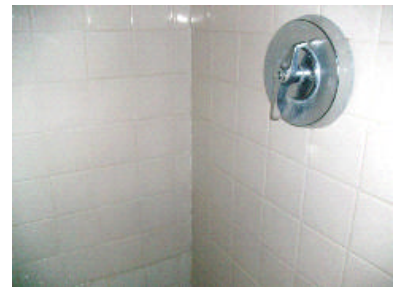
Employee Washrooms-Showers: Women's - regrout.

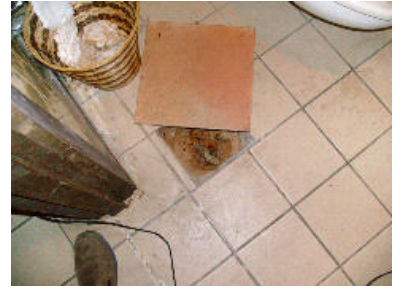
Employees bathroom - basement - open floor drain
- inoperable.

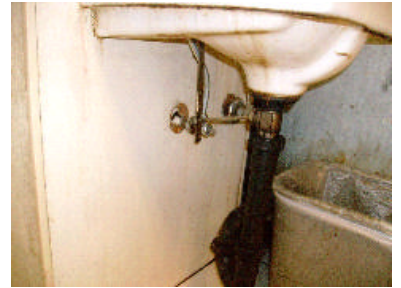
Missing shutoff - kitchen hand sink.

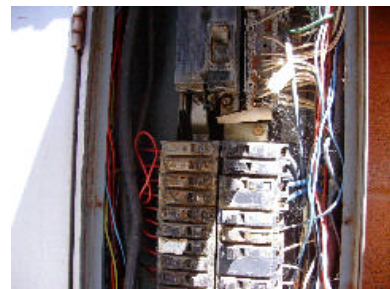
Locations & Condition: Rear door exterior - weather damaged - may need replacement.
 Basement panel A - okay, Panel B - okay.
 J box & J box2- basement kitchen - improperly decommissioned - open gaps - live wires.
 Panel I - missing covers.
 Panel L - over fused wire on 30 amp breaker.
 Panel J 1 okay.
 Panel J okay.
 Panel A okay
 Panel B okay.
 Kitchen - Panel P - okay.

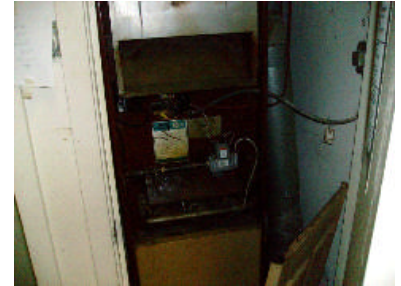
Irregular flame. Possible heat exchanger leakage.
 Improper vent - fire hazard.
 No drip arm.

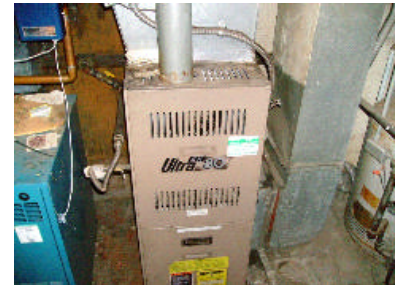
Basement kitchen - forced air, no drip arm.

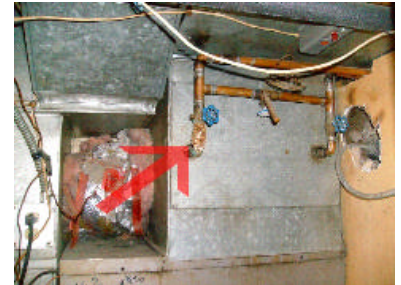
Air handler - basement closet - extreme corrosion on shutoff.

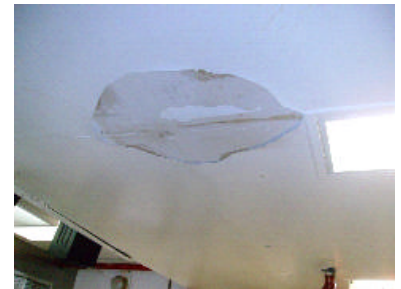
Ceiling areas with dry stains caused by prior leaks are noted in the following areas: kitchen by S door, by steam tables.

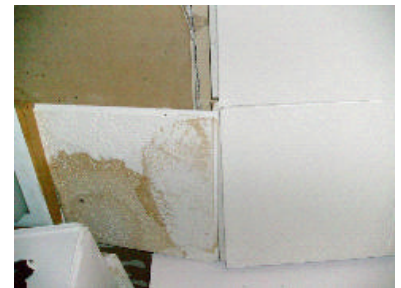
Possible asbestos ceiling tiles - women's bathroom in kitchen.

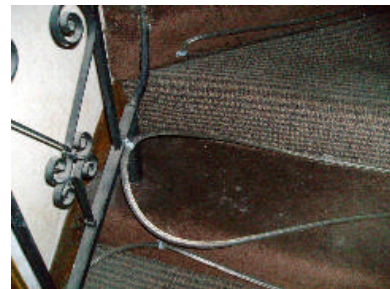
Stairs to basement - repair light rope, handrail loose, second step from top loose.
