**Inspection Perfection Inc**  
386 Quartz Circle  
Bailey CO 80421  
303-816-5556  
info@inspection-perfection.com

**Report:** historic office warehouse **Address:**

## **Confidential Inspection Report**

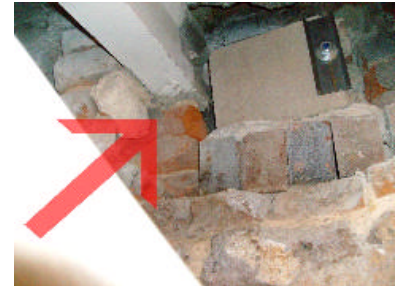
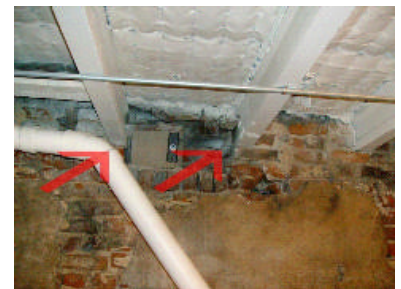
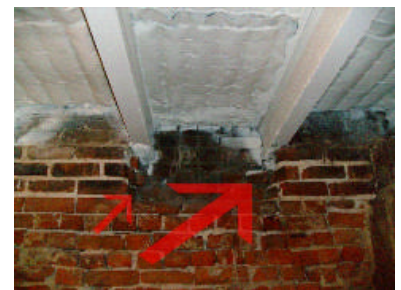
2 x 8 spaced at 24 inch centers, Concrete joist - basement - unsupported joist.

Have structural engineer check newly discovered issues like the deteriorated beam supports in the basement.

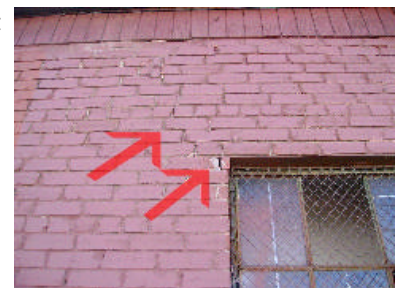
Broken brick and stair step cracking - rear above rt window.

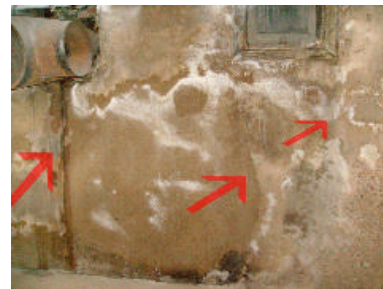
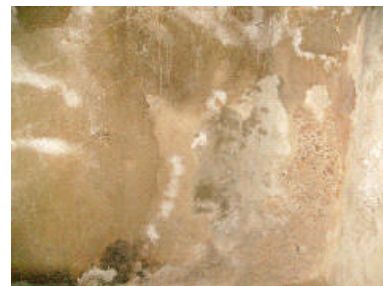
Water penetration - basement north - minor cracks visible - parge coat hides wall. Moisture meter indicates high level of moisture.

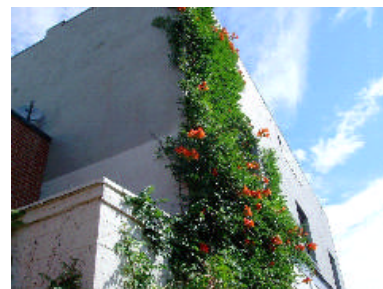
Vines on masonry will deteriorate joints. Trim vines where they have penetrated structure and install trellis to protect the wall or remove.

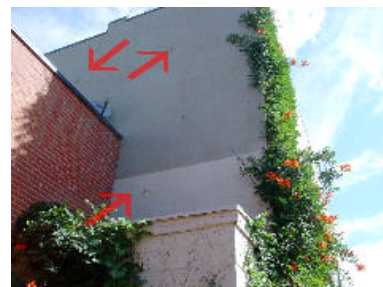
Walls have been stabilized in past.

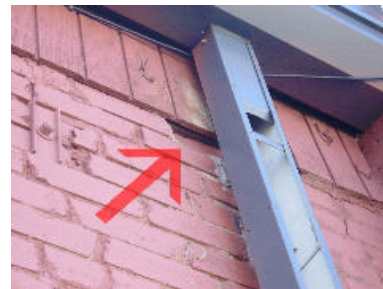
Damaged brick behind downspout - rear rt. Seal.

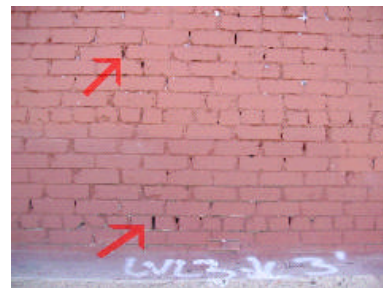
Tuck pointing needed - rear. This is more expensive than you'd expect. Please get a bid for repair.

Get bids for tuck pointing.

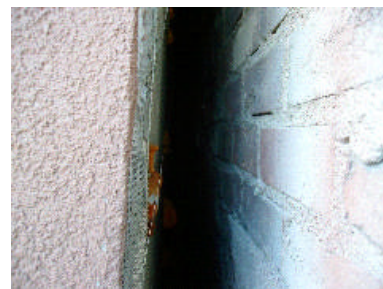
North wall bowed.

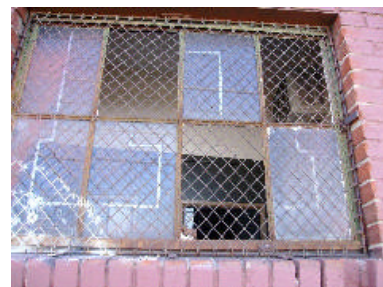
Missing panes x 3 rear.

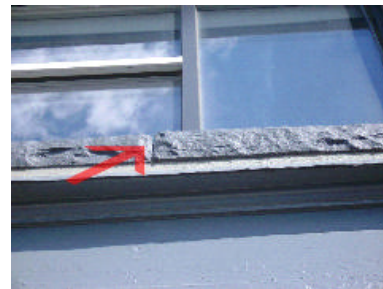
Masonry - repair 2nd story front - reported leaking profusely.

*Type and Condition of Sills/Lintels:* Masonry - repair 2nd story front - reported leaking profusely.

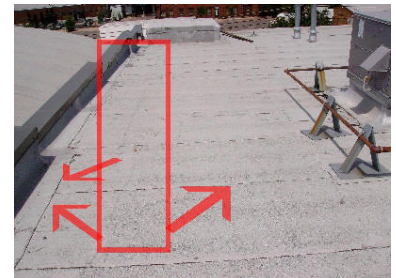
Flat with Fiberglass roll roofing. Improper installation with inadequate or no overlap.

**note cracking beginning to show**

Replace roof covering with Bituminous membrane, it is due now.

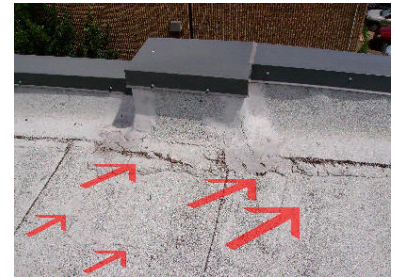
Primarily due to the age of the roof covering or underlayment and its limited anticipated remaining economic service life. While no active leakage is noted, this roof is at the point in its life where leakage can be expected to occur over the next few years. Roof covering is approaching the end of its life expectancy. Water blister noted.

Primarily due to the age of the the roof covering or underlayment and its limited anticipated remaining economic service life. While no active leakage is noted, this roof is at the point in its life where leakage can be expected to occur over the next few years. Roof covering is approaching the end of its life expectancy. Water blister noted.

**note alegstoring and deteriorated flashing**

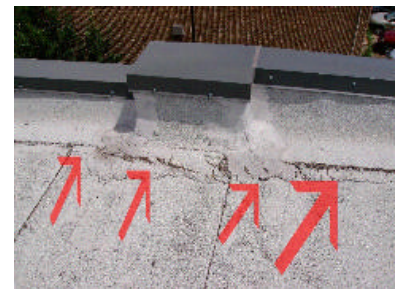
Deteriorated.

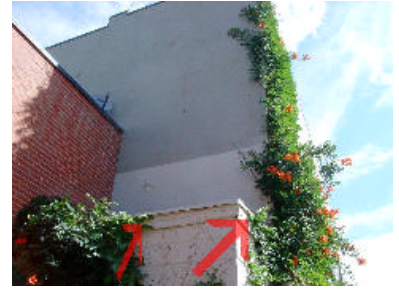
Vines under flashing - front left low flat roof.

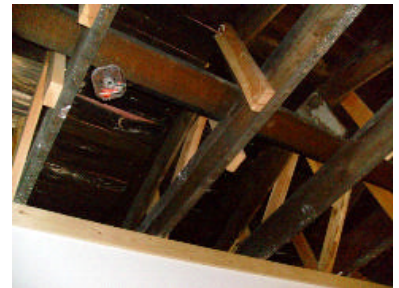
Original roof deck shows signs of past fire and water damage.

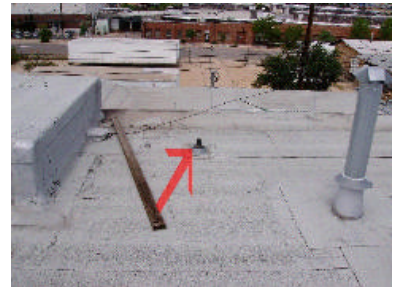
minimal - roof vent too short - can be blocked by snow.

- Sewer:* Sewer.
- Interior Waste Lines: Predominant Type:* PVC, Cast Iron and Copper.
- Drainage:* Clogged floor drain bull pen.
- Venting:* minimal - roof vent too short - can be blocked by snow.

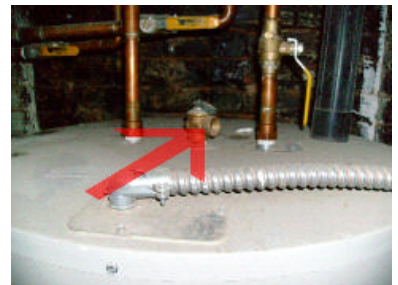
Extend safety pressure relief to floor - main heater.

- Primary Water Heater Type:* Electric.
- Size in Gallons:* 80.
- Year of Manufacture:* 1997.
- Equipment Condition:* Extend safety pressure relief to floor - main heater.

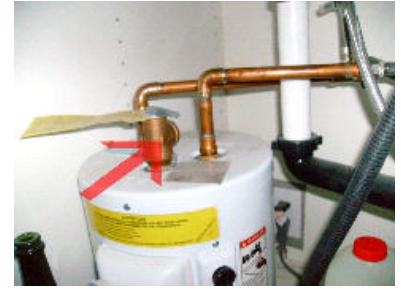
and small unit under bull pen sink.

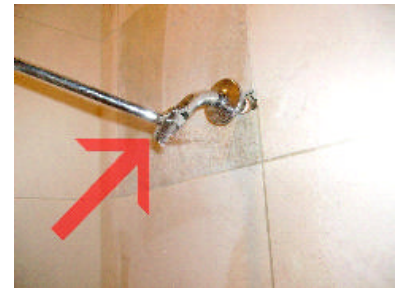
Shower head extension leaks - upstairs south.

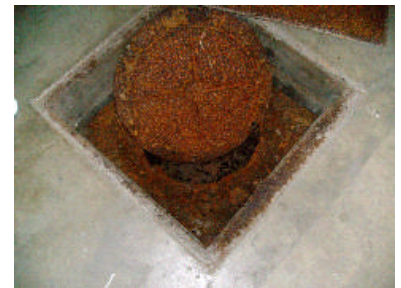
Floor drain and underground drainage system in bull pen not functional - full of water. Scope.

The whole drain system should be scoped to identify what is and is not working.

Have all sewer lines scoped with bid for repair.

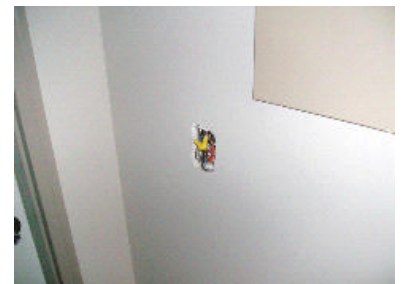
Live wires open junction box rear exit upstairs south.

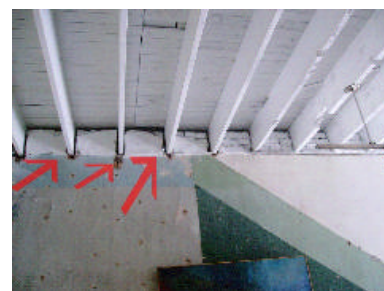
Caulk ceiling rafters - waiting room.

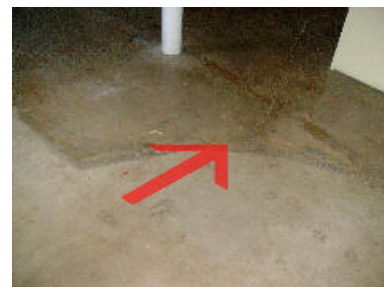
Moderate cracking - bull pen.

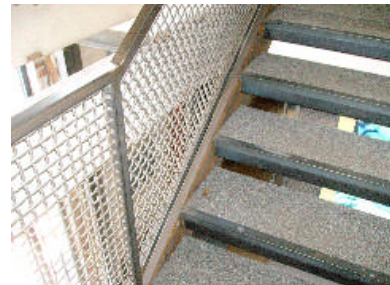
Stairs to second floor - handrail too low at second turn going up.

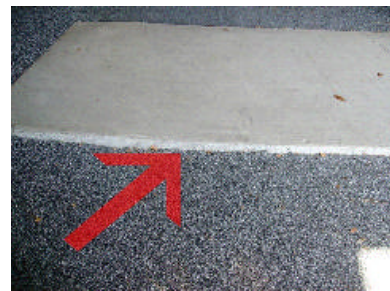
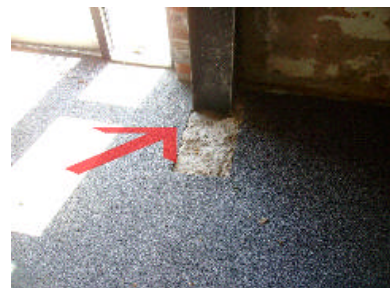
Trip hazards x 2 front lobby.
